Re: Portland Harbor Fish Tracking Pilot Study, June 2017

To	Deborah Edwards/ExxonMobil	Page 1
CC	Dave Roberson/de maximis, inc., Christa Woodley/USACE ERDC, Roy Leidy/AECOM	
Subject	Summary of Fish Tracking Pilot Study – Lower Willamette River	
From	Betsy Ruffle and Ryan McCarthy	
Date	September 12, 2017

This memorandum summarizes the fish tracking pilot study performed from June 12 to June 19, 2017 in the Lower Willamette River in Portland, Oregon. A summary of the design and results is provided, and recommendations for vendor selection are provided. The scope of work for the pilot study was developed in collaboration with Karl Gustavson, U.S. EPA Office of Superfund Remediation and Technology Innovation (OSRTI), who has extensive experience designing and implementing fish tracking studies. The pilot study was discussed with Sean Sheldrake of U.S. EPA Region 10 and Karl Gustavson at a meeting in February 2017, where the pilot study design and candidate locations for equipment installation were discussed. Dr. Christa Woodley, Senior Fisheries Scientist with the U.S. Army Corps of Engineers, Engineer Research and Development Center (ERDC), also assisted with study design, particip

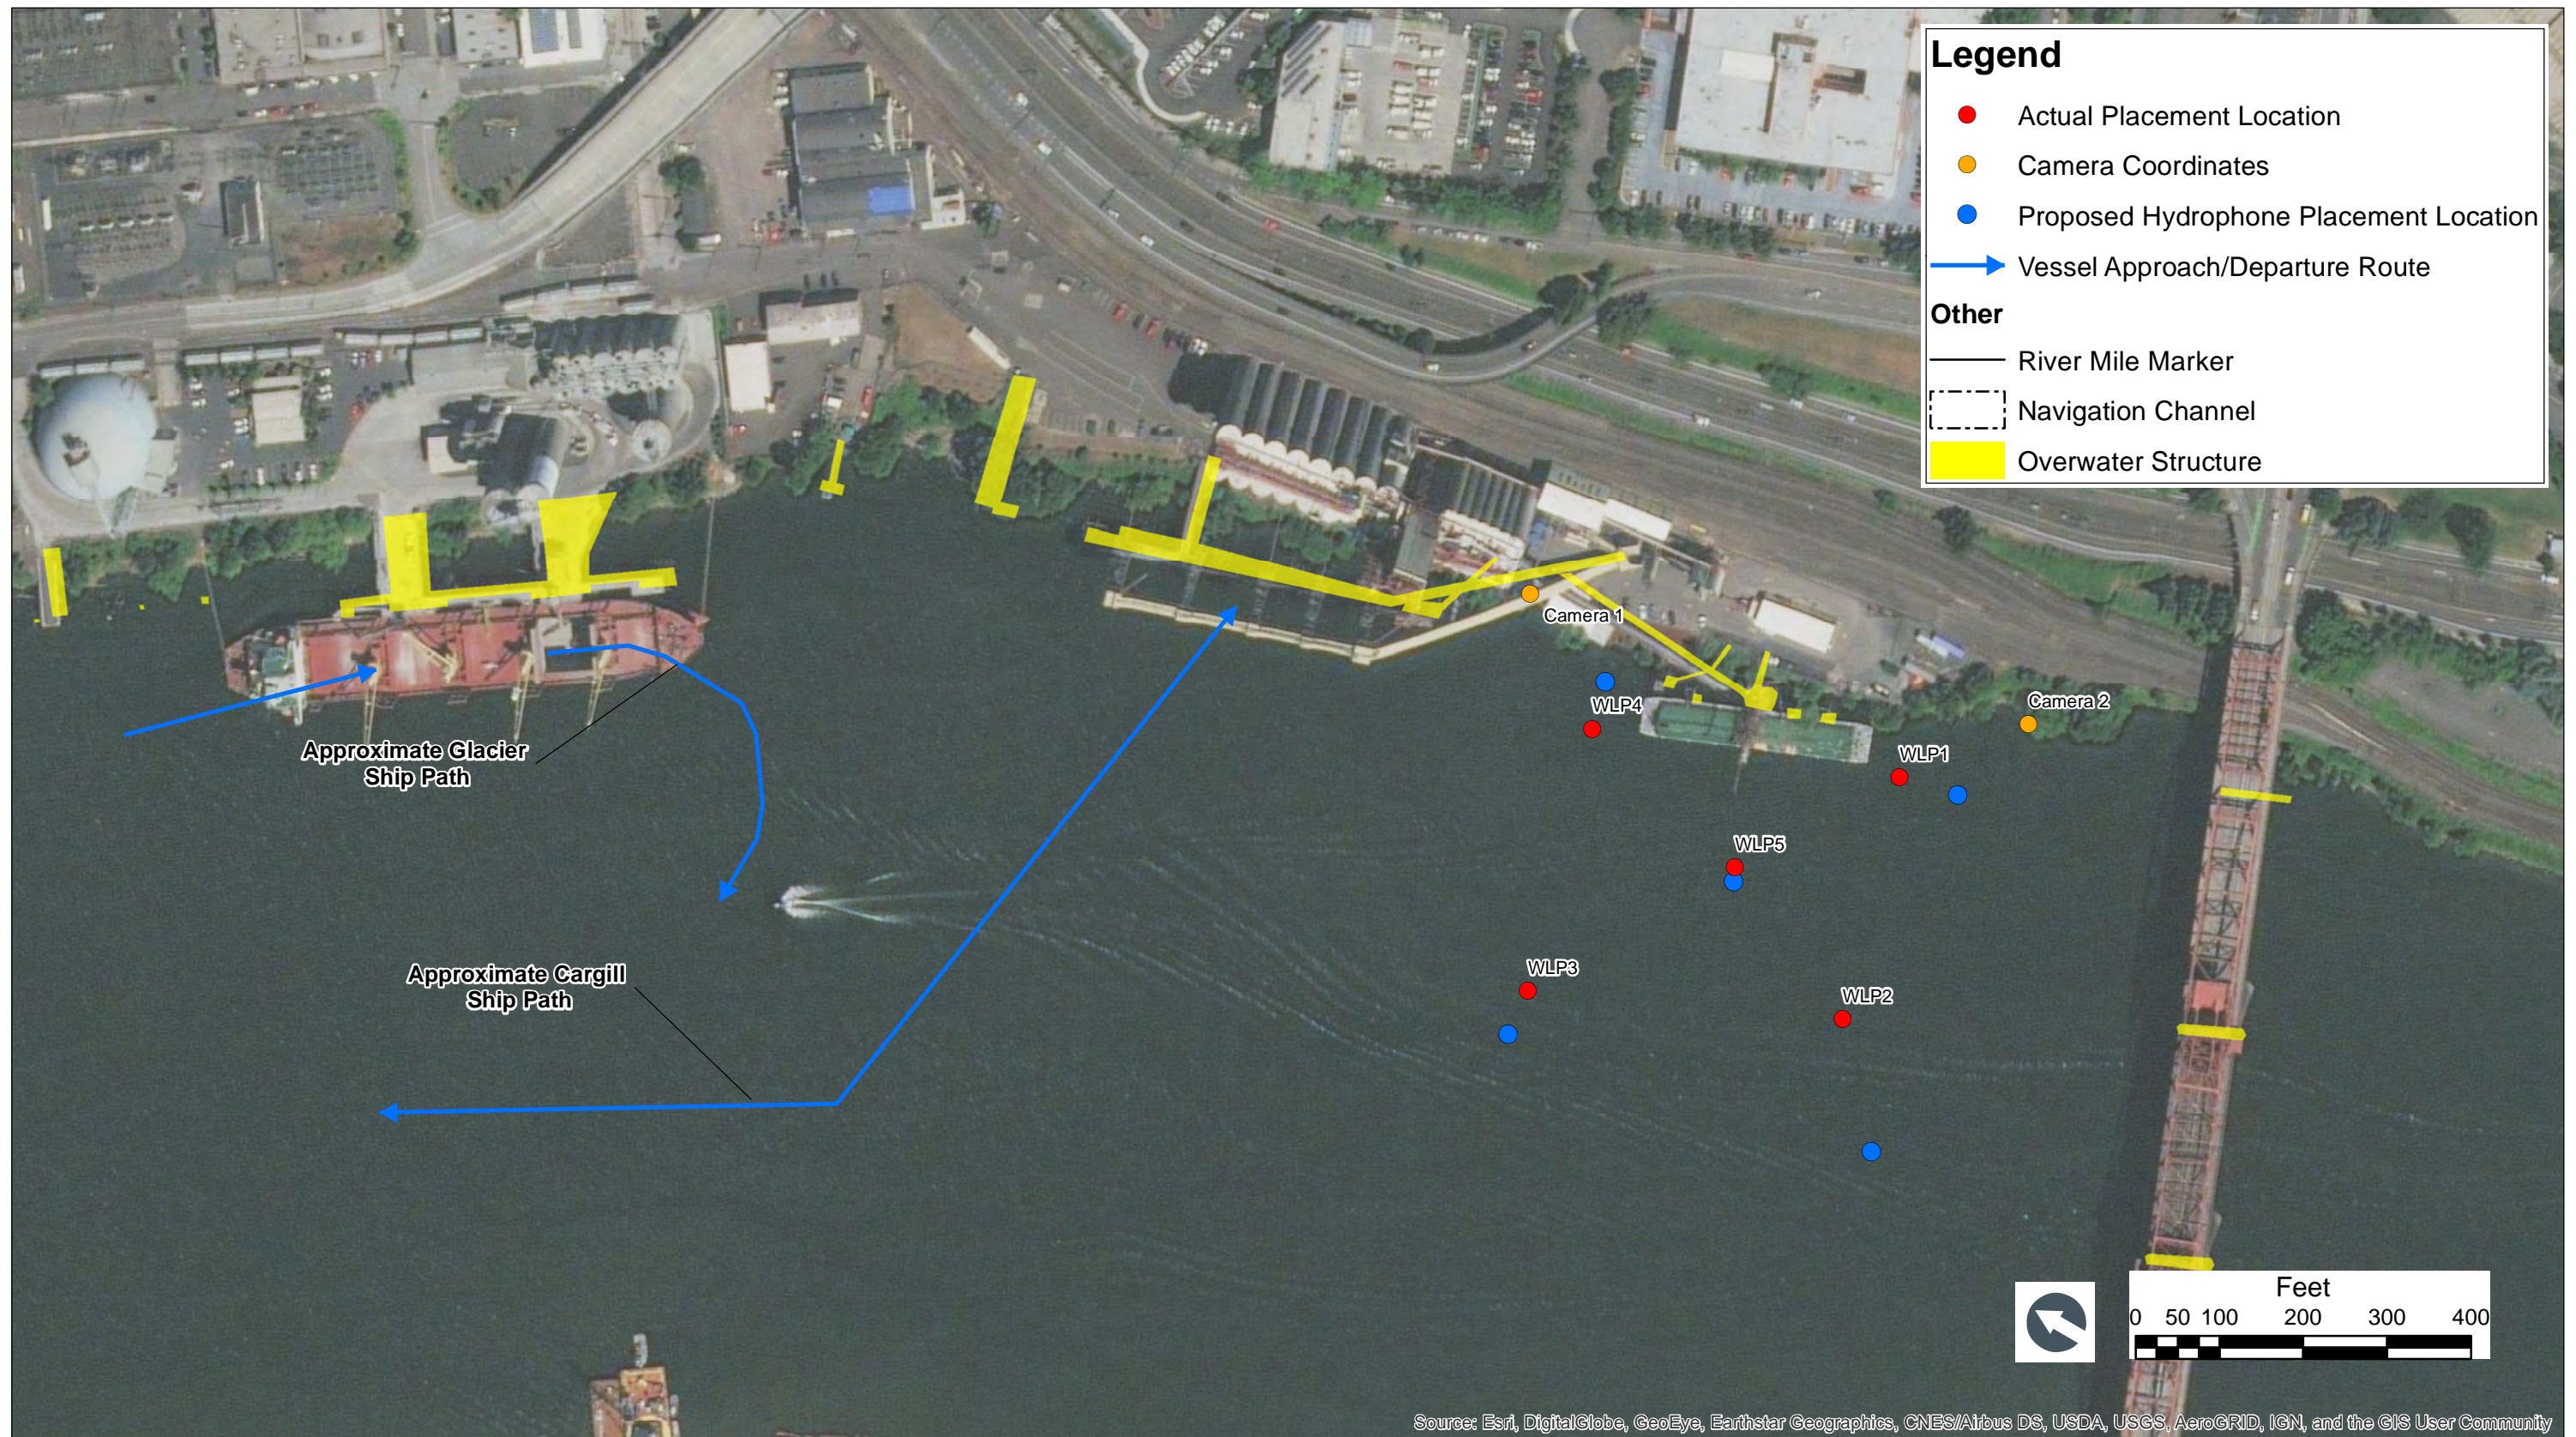
Figure 1
Vessel Routes and Actual Hydrophone and Camera Locations at RM11.5E Study Area
Lower Willamette River Fish Tracking Pilot Study
Portland Harbor Superfund Site

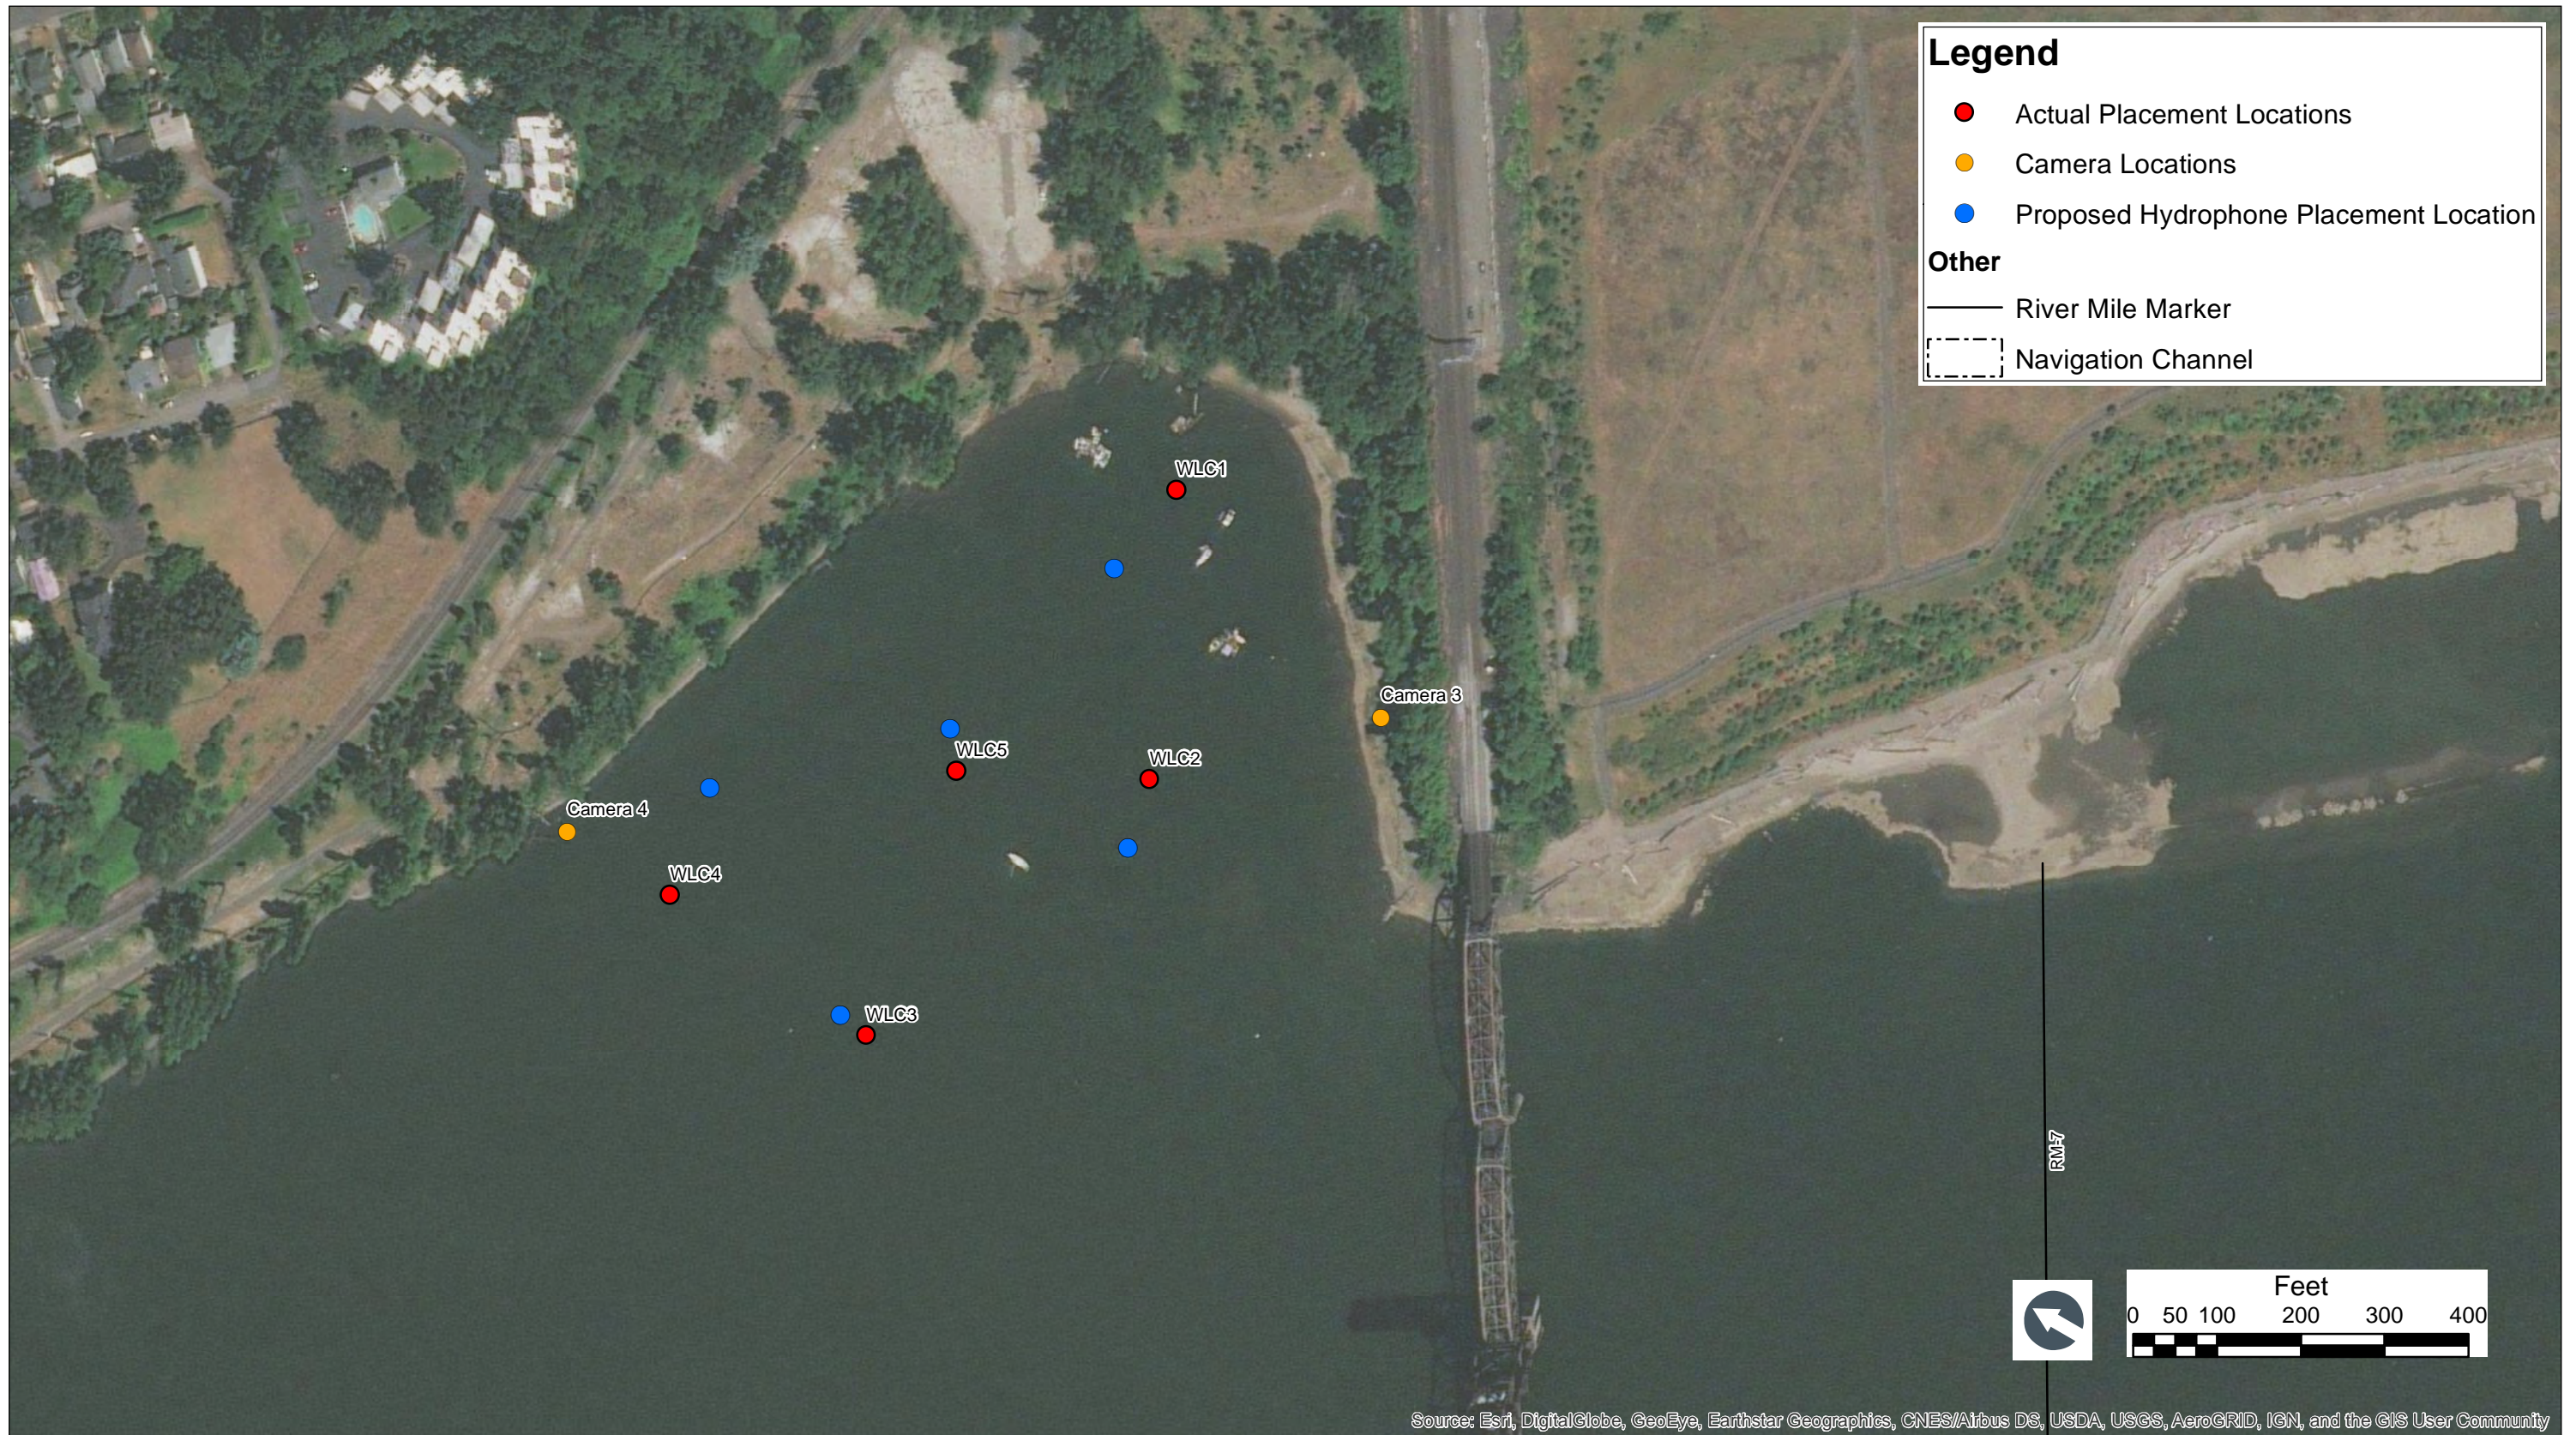
Figure 2
Actual Hydrophone and Camera Locations at Willamette Cove Study Area
Lower Willamette River Fish Tracking Pilot Study
Portland Harbor Superfund Site

Cove Site (Willamette Cove): The dimensions of the Cove site (Willamette Cove) acoustic array was slightly adjusted during deployment due to resident boaters in the Cove. The quadrilateral post-deployment was 106m x 139m x 88m x 237m. The site was chosen for its gradual bathymetry, fine-sediment dominance (> 60%), quiescent to low flow and quiet acoustic conditions.

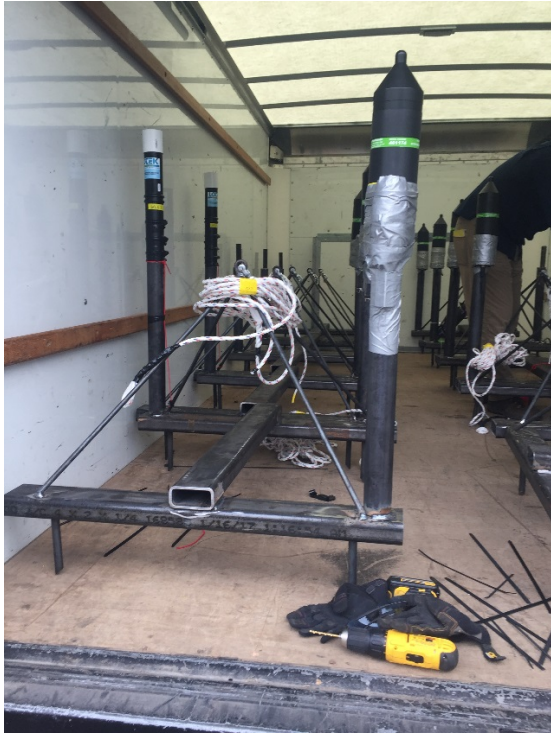
Photograph 1 ↑
Bottom Mounts outfit with HTI Hydrophone

In order to meet the project objectives, acoustic receivers/hydrophones from both vendors (Lotek Wireless, Inc. and HTI-Vemco) were co-deployed on a rugged steel bottom mount that was specially fabricated for this study. The pilot design involved deployment of five mounts at pre-determined locations in both study areas. In addition to the receivers, transmitters were installed at varying distances to test the range and reception of the “pings” by the hydrophones that were deployed at the bottom of the river. A transmitter (tag) from each vendor was deployed on the same mooring at three locations representing optimal and sub-optimal distances from the hydrophone array. In addition to the use of fixed tags (which were left in place for the one week duration of the pilot study), a set of mobile tags were dragged by boat through the array at varying distances to provide another measure of acoustic range and reception with distance.

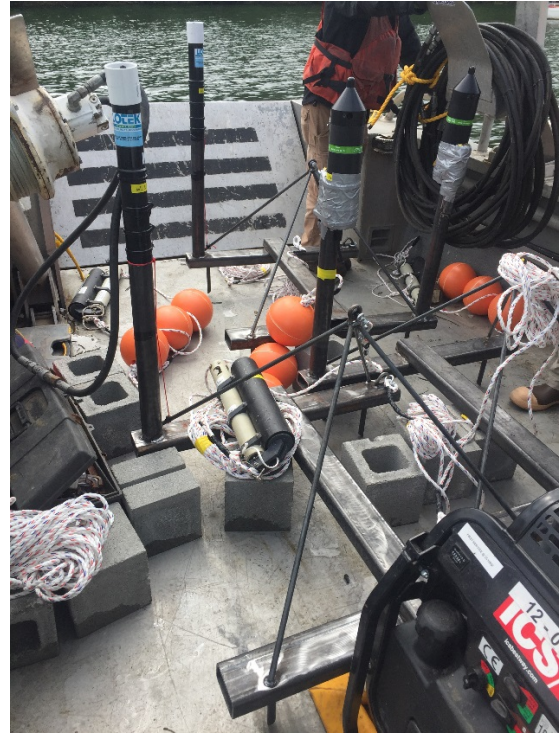
Photograph 2 ↑
Bottom Mounts on Deck of Research Vessel

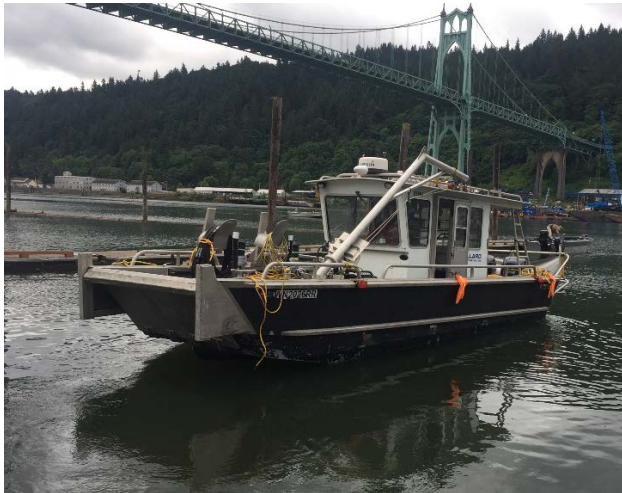
Photograph 3 ↑
Ballard Marine's R/V Argos

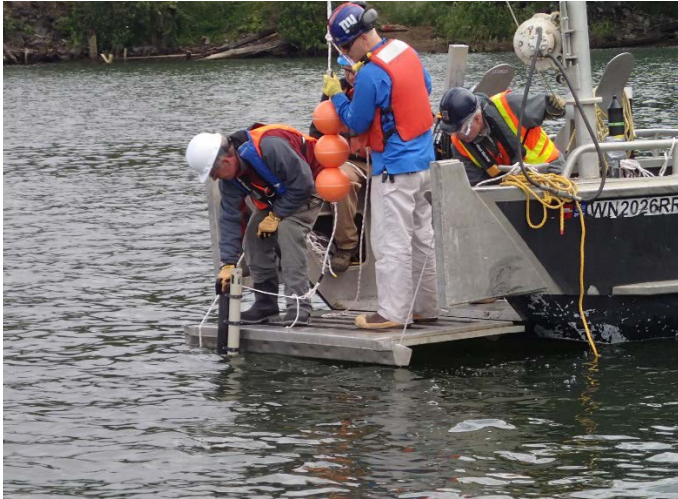
Photograph 5 ↑
Preparing acoustic release for deployment

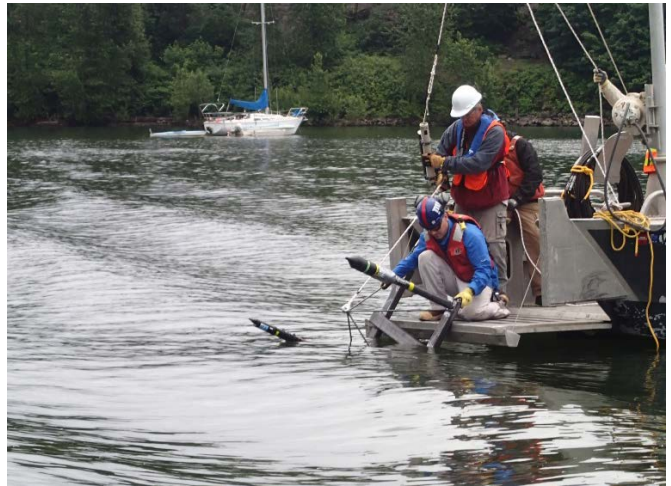
Photograph 6 ↑
Deploying bottom mount with acoustic receivers

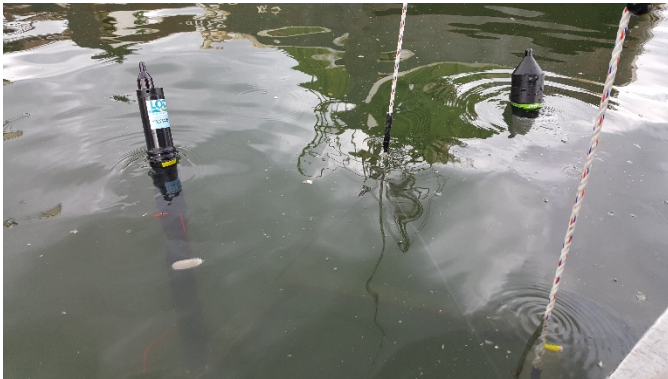
Photograph 7 ↑
Lotek and HTI hydrophones being deployed

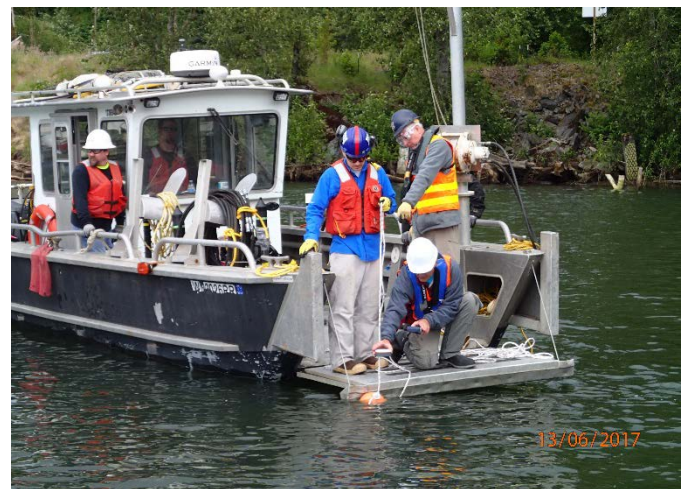
Photograph 8 ↑
Recording GPS position of deployed bottom mount

Once on the bottom, a survey grade GPS (Juniper Geode and Sokkia handheld) recorded the as deployed position of each bottom mount. The buoy/ looped line was then released, and the bottom mount was left on the river bottom to record data. The tag line had two half-8 cinder blocks attached and then dropped overboard. This ground line served as a backup recovery option should the acoustic release fail during recovery.

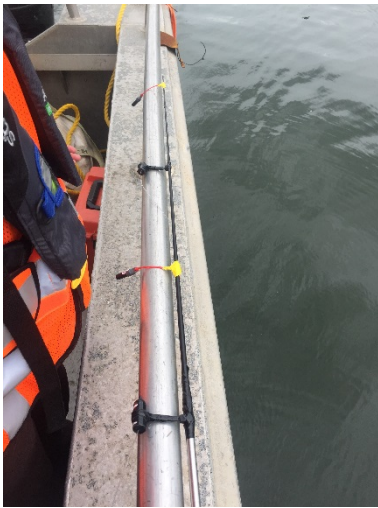
Photograph 9 ↑
Fish tags mounted to rod for drift tests.

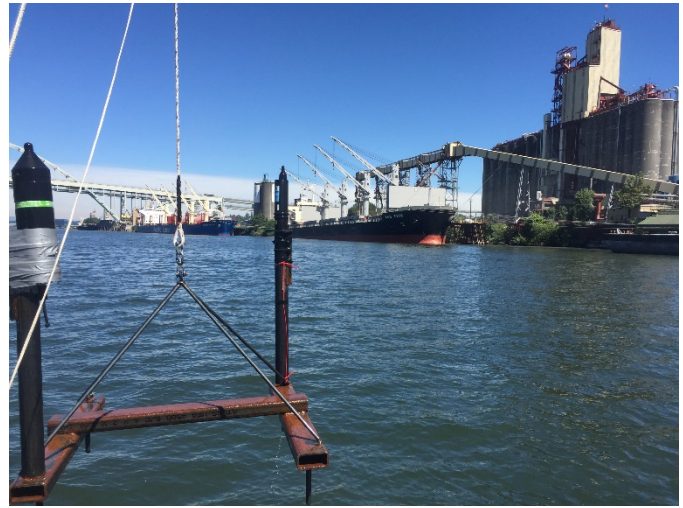
Photograph 10 ↑
Bottom mount being recovered after week of deployment

At the RM11.5E study area, four out of five acoustic releases operated properly and those moorings were recovered. The fifth mooring was dragged for with a grapple and successfully found/ recovered. It was later determined that an internal part of the release was damaged and prevented the proper operation of the release. The fixed tags were dragged for using a grapple to attempt to snag the ground line. None of the fixed tags were recovered using this method at the RM 11.5E site. After

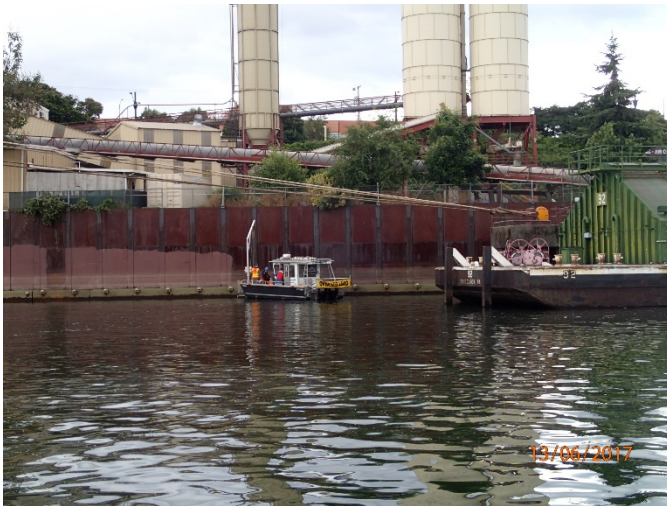
Photograph 11 ↑
Typical barge/ bulkhead environment at RM11.5E

- Sec 3.2/4.1: Based on acoustic work carried out in many Ports, the RM11E Port area is an acoustically challenging environment owing to the hard reflective surfaces presented by walls and the hulls of ships and barges. Additionally, the noise and air entrainment associated with the operation of propellers further degrades the acoustic environment. From a hydro-acoustic perspective, Ports typically represent a challenging environment, with high levels of anthropogenic noise and many highly reflective surfaces which encourage multi-path.

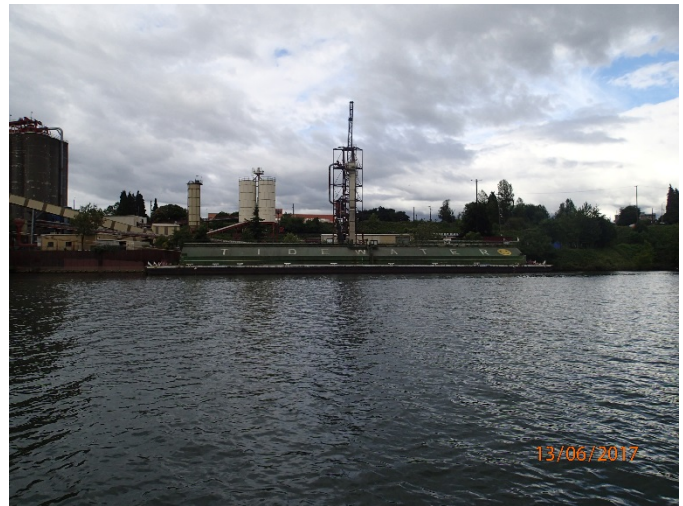
Photograph 12 ↑
Typical Barge at RM11.5E

The majority of the activity captured by each camera was boat and barge movement. Boats in transit were most commonly observed. Generally, the view of the study area at RM 11.5E was somewhat restricted by the changing position of the barges at Cargill and the limited surfaces available in the area for camera attachment. The opposite side of the river was assessed on Day 1, but was determined to be at too great a distance to monitor activity at the study site. Activity at Camera 1 was highest on June 13 and 14 when multiple barges entered and exited the Cargill docks throughout the day. Camera 1 captured one night photo of a vessel moving through the area. The field of view of Camera 2 was partially obscured by vegetation, and most frequently captured tugboats moving in and out of Cargill's port.

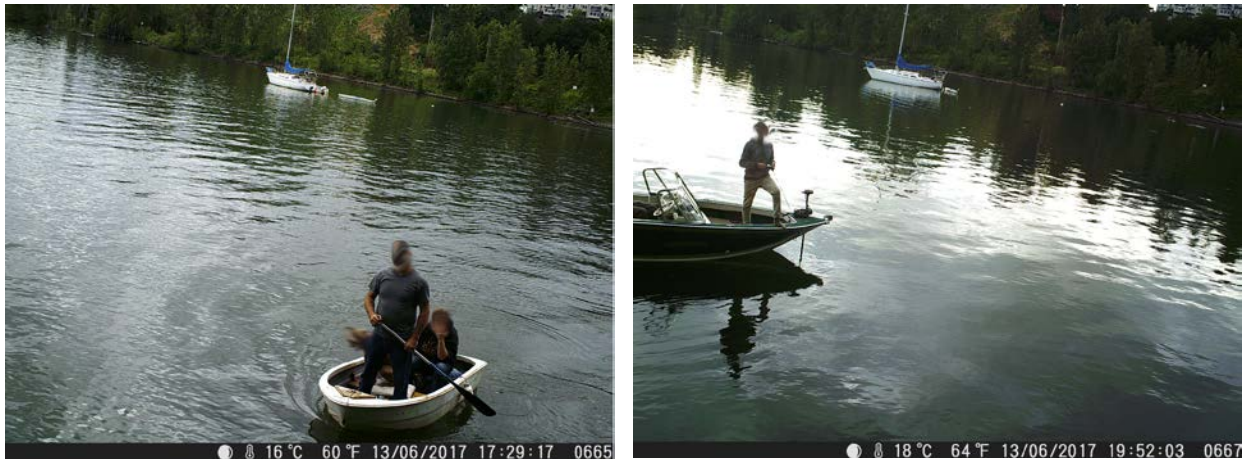
At the Willamette Cove location, activity increased on the weekend (June 17-18), due to increased transit of private boats in the cove. Several private boats were anchored in the cove at RM 6.8 and occasionally left and returned, or changed position. A tree branch in front of Camera 3 caused the camera to deploy over 600 times in the first 24 hours; during the maintenance check on Day 2, the branch was removed and the sensitivity setting was changed from "Low" to "Medium", which resolved the issue. The field of view from Camera 3 included private boats moored in the cove. Photos of people viewing Camera 3 were captured twice, at different times on June 13 after the maintenance check (Figure 3). None of the cameras were tampered with.

Figure 3. Spectators observing Camera 3 from the water in Willamette Cove.

Besides the June 13 photo of the individual possibly line fishing (Figure 3, right photo) and another possible line angler in Willamette Cove on June 18, no photos of anglers or fishing activity were captured during the week-long study period.

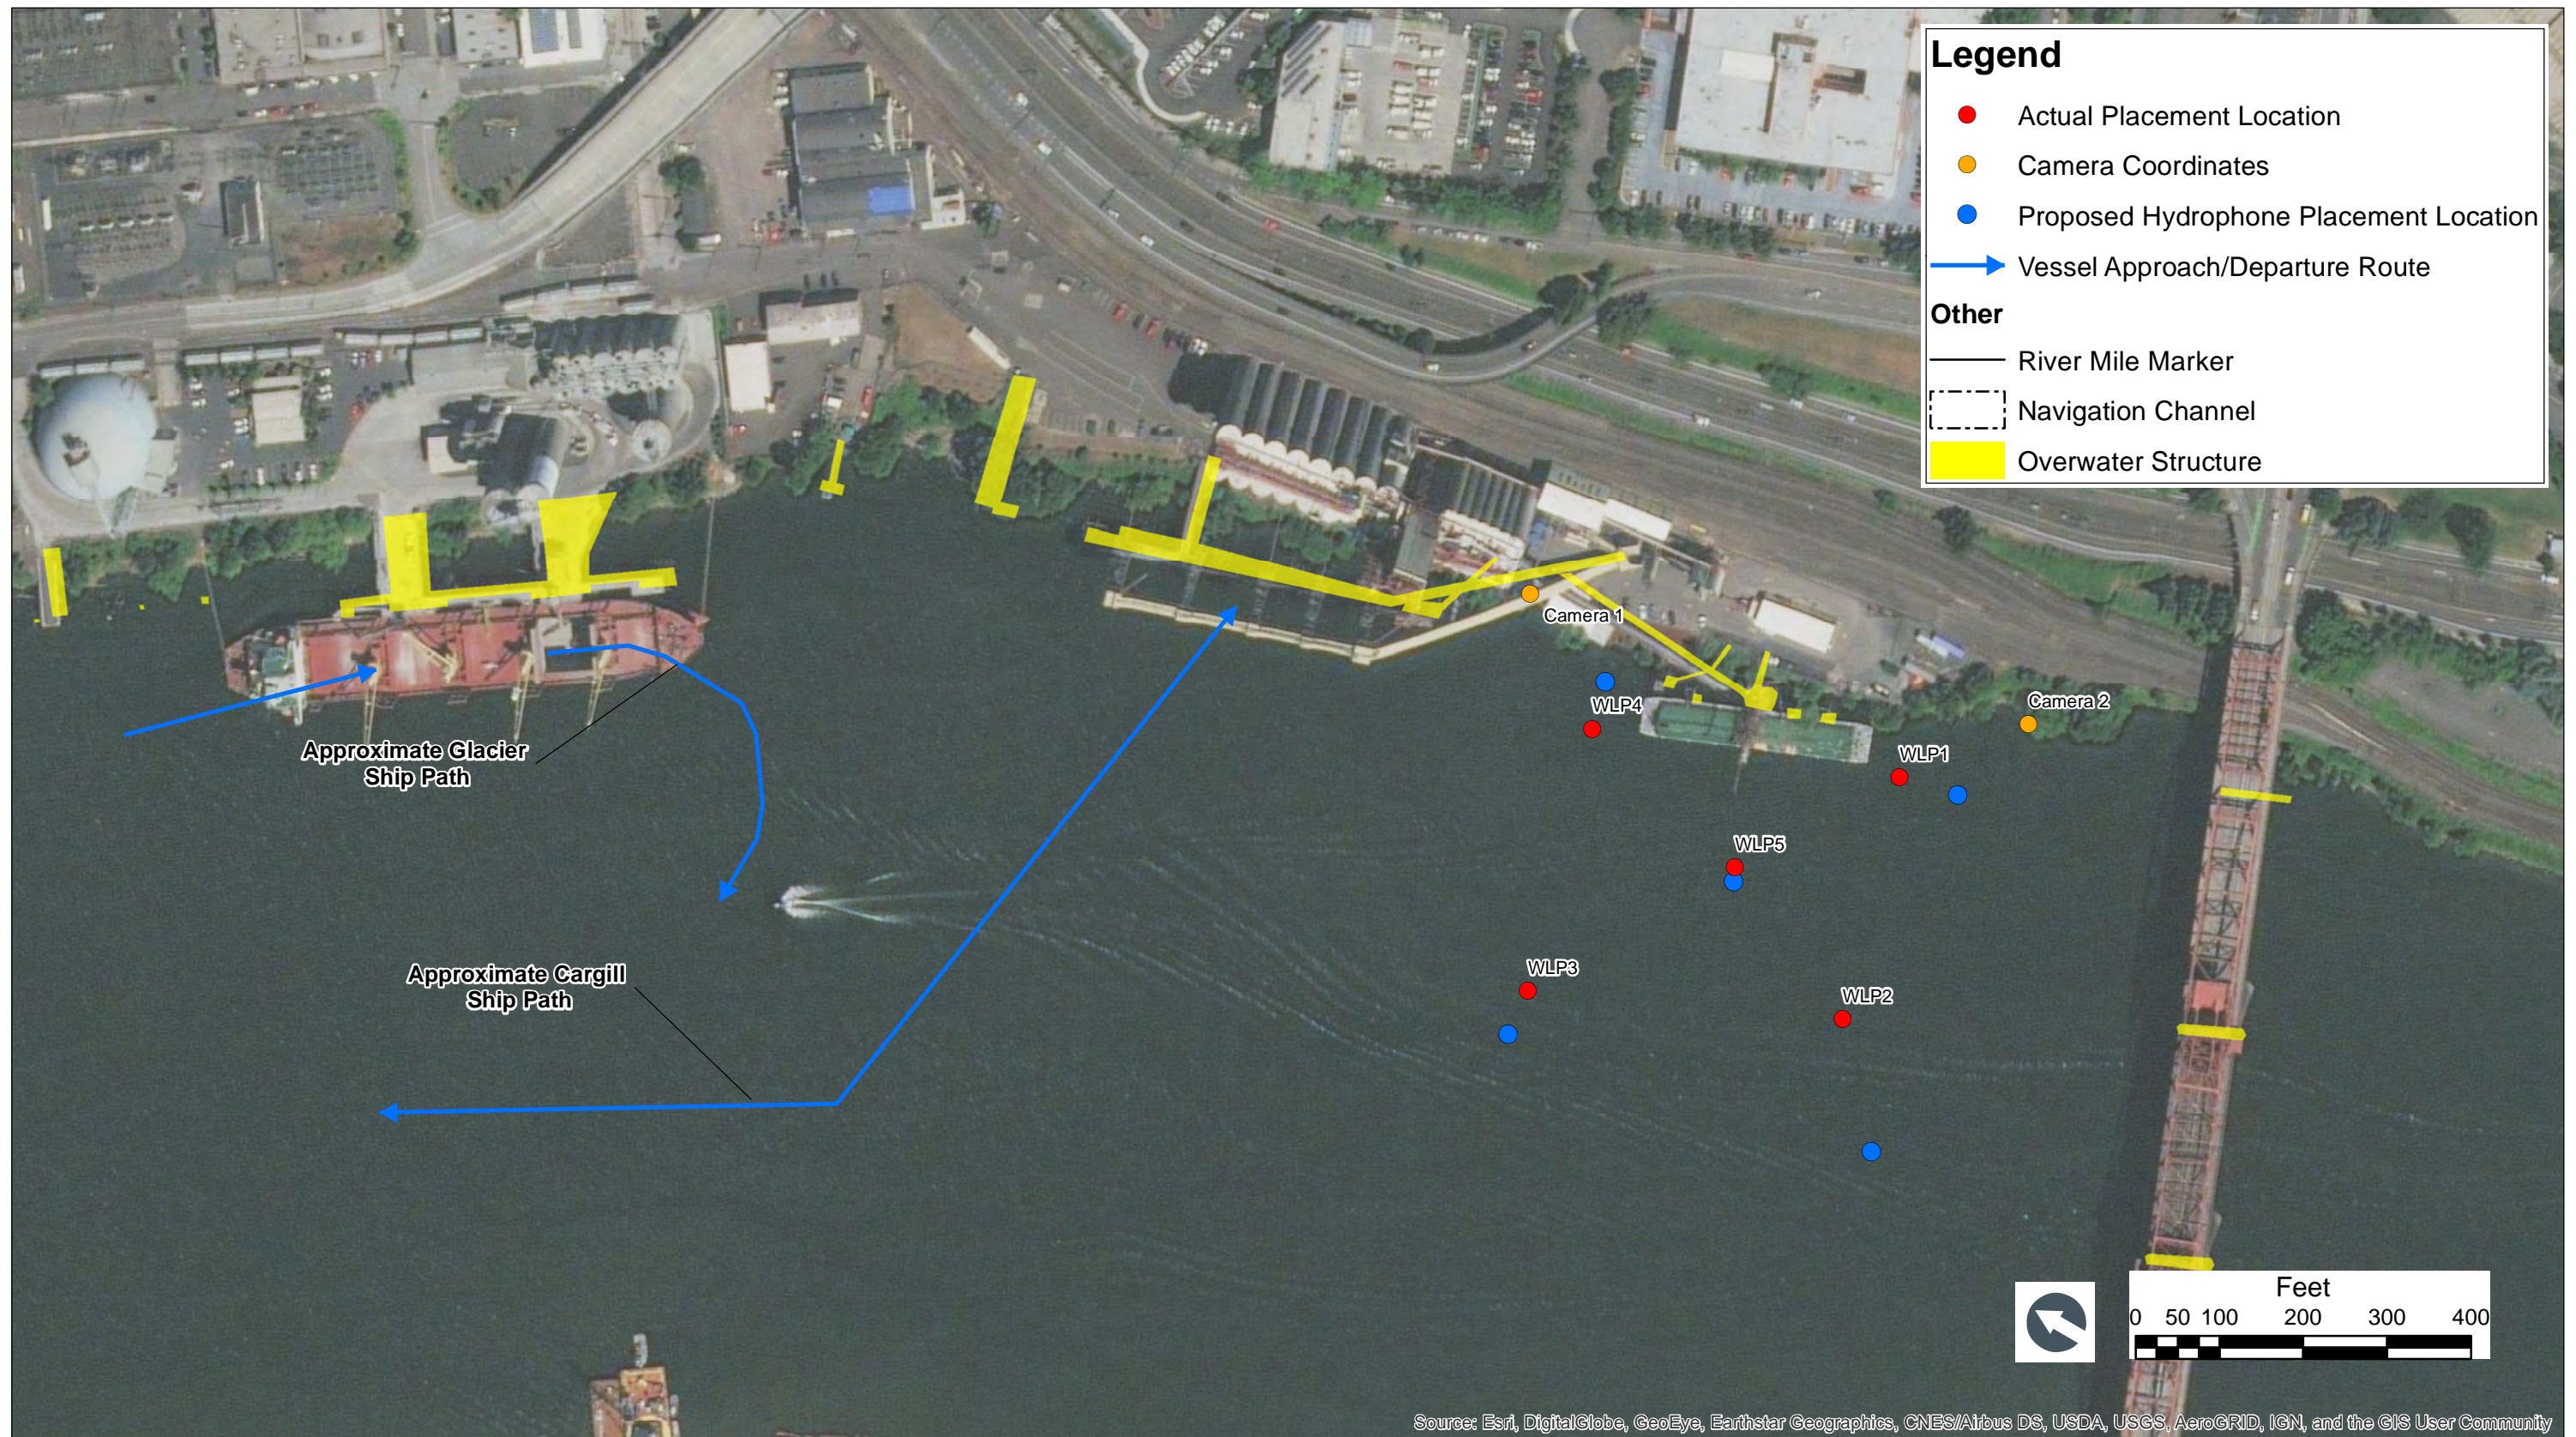
Figure 1
Vessel Routes and Actual Hydrophone and Camera Locations at RM11.5E Study Area
Lower Willamette River Fish Tracking Pilot Study
Portland Harbor Superfund Site

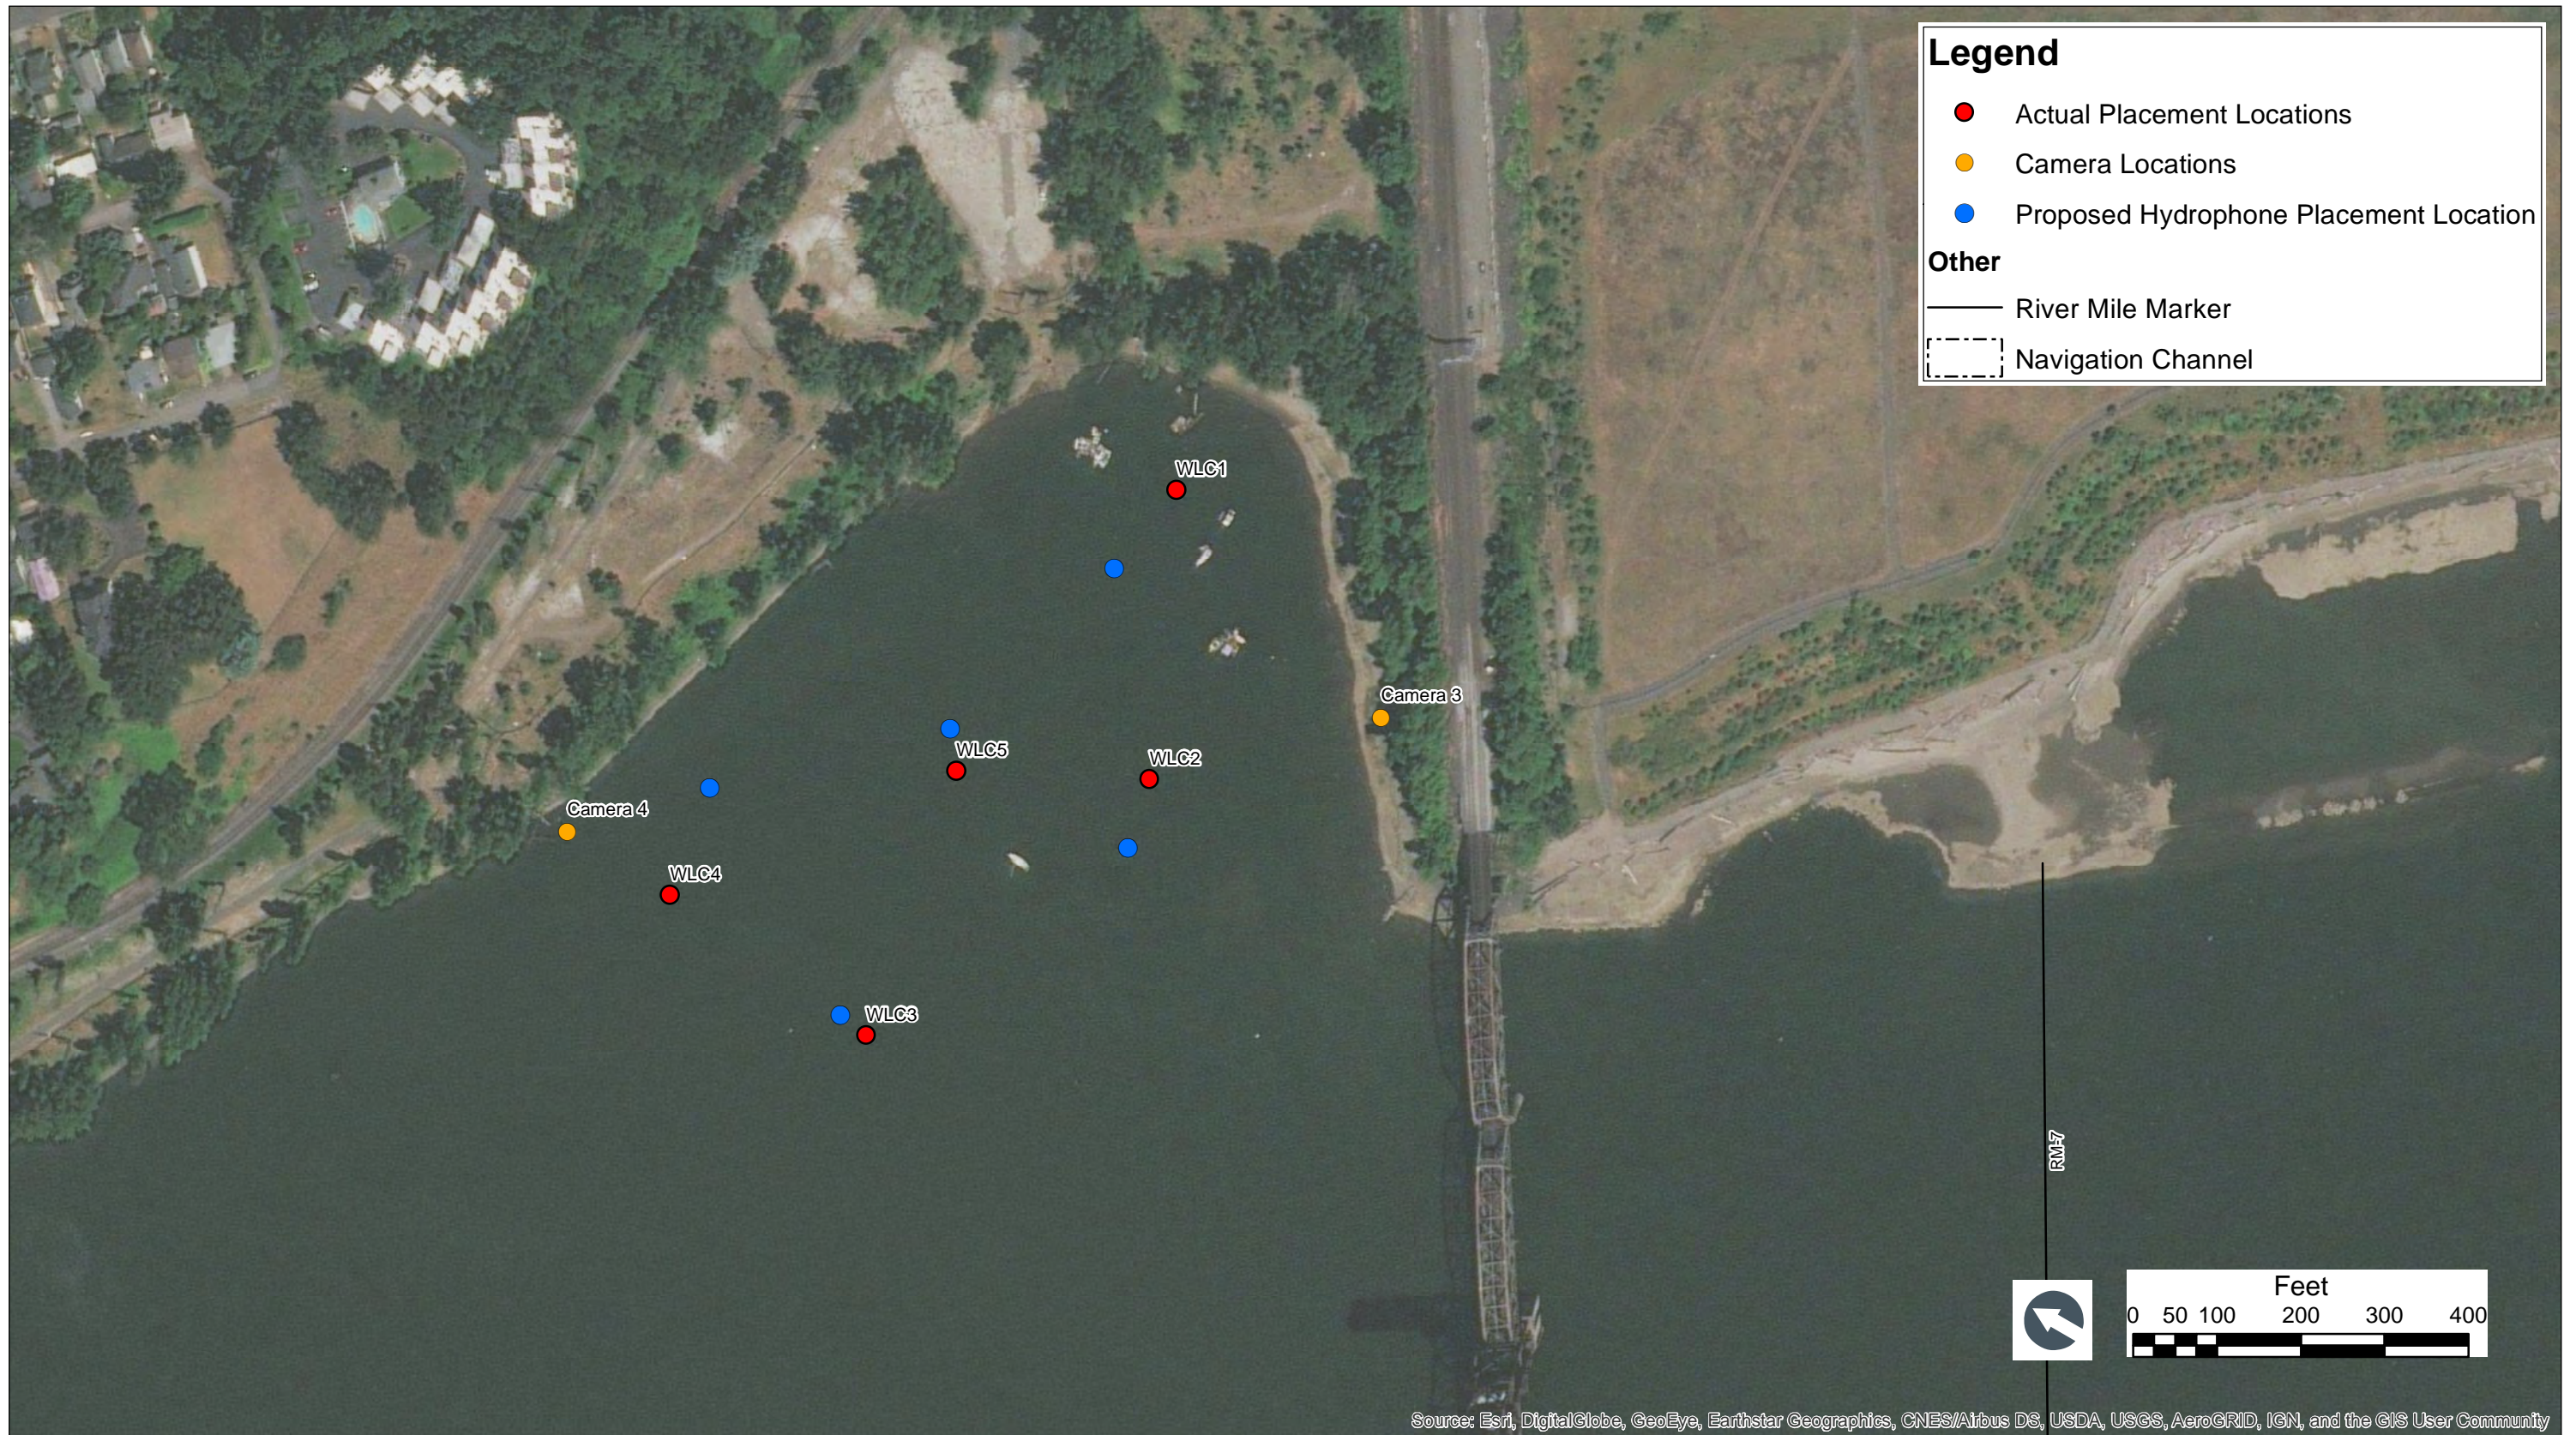
Figure 2
Actual Hydrophone and Camera Locations at Willamette Cove Study Area
Lower Willamette River Fish Tracking Pilot Study
Portland Harbor Superfund Site

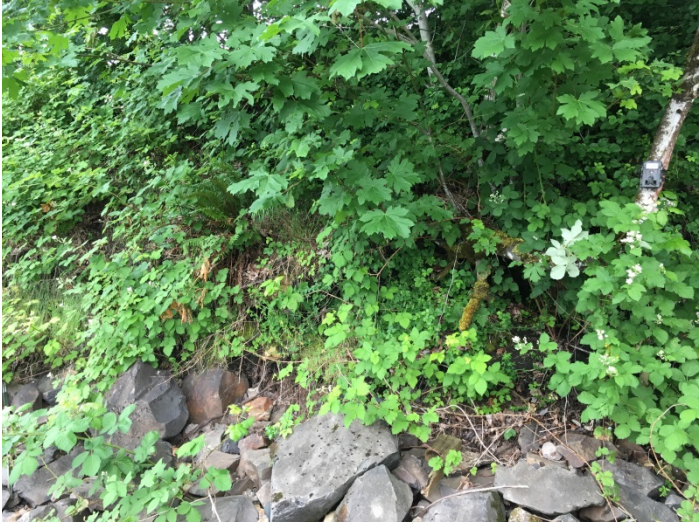
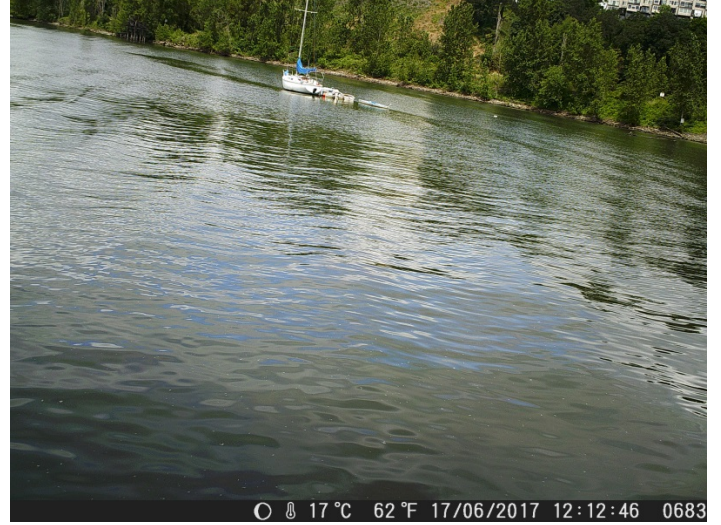
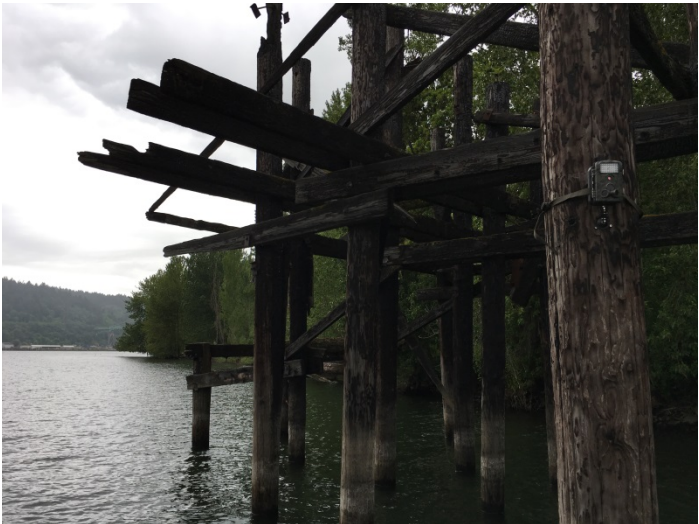
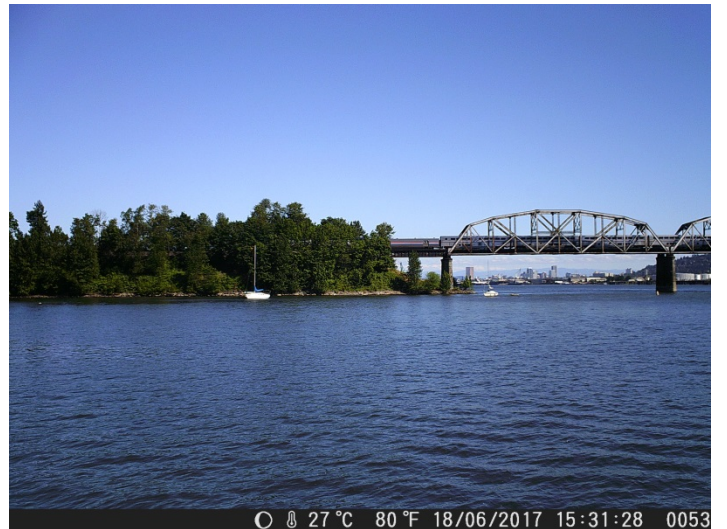
Placement and Field of View for Cameras 3 and 4 at Willamette Cove

Camera 3 placement.

Camera 3 field of view.

Camera 4 placement.

Camera 4 field of view.

* The large number of photos captured by Camera 3 on the first and second days were caused by a branch moving in front of the camera, which was removed on Day 2 of the study.
